# FILM NOTES FOR THE REEL PEOPLE

H-50-4

A TECHNICAL SERVICE FOR FILMHANDLERS FROM EASTMAN KODAK COMPANY

## TROUBLESHOOTING AND PREVENTION OF DAMAGE

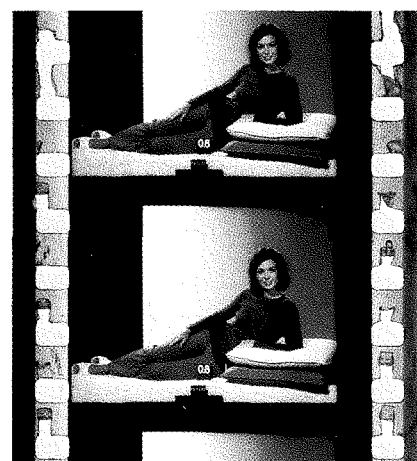
**Figure 1**

Few things are more distracting to a theatre patron than vertical image unsteadiness. Some of the causes are avoidable and some are not. If we can assume that the unsteadiness did not originate during the printing operation in the laboratory, the film should first be examined for perforation damage. If the perforation walls on the pulldown side are deformed and torn (Figure 1), there is little that can be done short of extensive and costly repair of the film edges. If the perforations are undamaged, the problem lies elsewhere. Read on!

*Torn perforations such as these generally cause an unwanted interruption of the film presentation.*

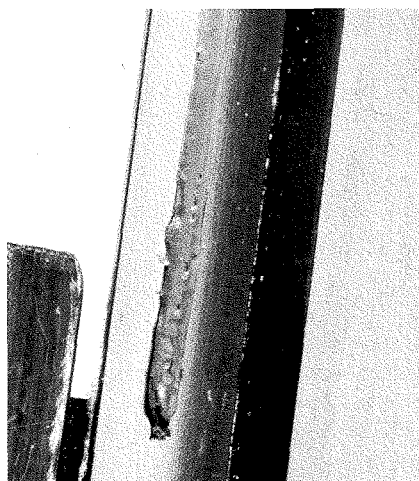
**Figure 2**

*This much emulsion deposited on the trap rails can cause excessive noise at the sprocket, picture unsteadiness, and deformed or torn perforations in the film.*

If a seasoned print produces these symptoms, there are probably deposits of emulsion or dirt on the trap rails from previous runs or from other mechanical causes. Old prints generally do not need further lubrication.

At the end of the run, the rails should be cleaned to remove any accumulated deposits. Use a small plastic scraper to remove the deposits followed by a final touch-up cleaning with a 50/50 water and alcohol solution applied with a soft cloth or cotton swab. Do not use metal to clean the rails because deposits form more readily once the highly polished metal surface is scratched. Ideally of course, to prevent a buildup of dirt where oil has been applied, the print should be sent to a professional motion picture laboratory to be cleaned and to have the appropriate lubricant applied to the emulsion side edges of the film.

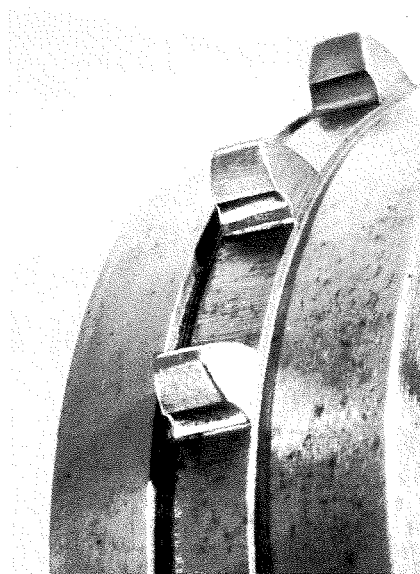
**Figure 3**

*Worn sprockets should be replaced.*

Consider the intermittent sprocket first. This sprocket is precision engineered and manufactured to very close tolerances. The teeth are hardened and capable of long service, but with time they can wear. The first indication of tooth wear is a ticking sound as the film leaves the sprocket. The ticking is most noticeable when you advance the film by hand. At this stage, steadiness generally is not affected, but once the groove worn into the base of the tooth becomes deep enough (Figure 3), unsteadiness can develop. Providing that there are no other types of tooth damage, such as burrs or broken teeth, the sprocket sometimes can be reversed as a temporary measure. However, a new sprocket should be installed as soon as possible. While the other sprockets in a projector do not usually contribute directly to unsteadiness, they should also be checked for wear and damage because they can also cause perforation damage. If the intermittent

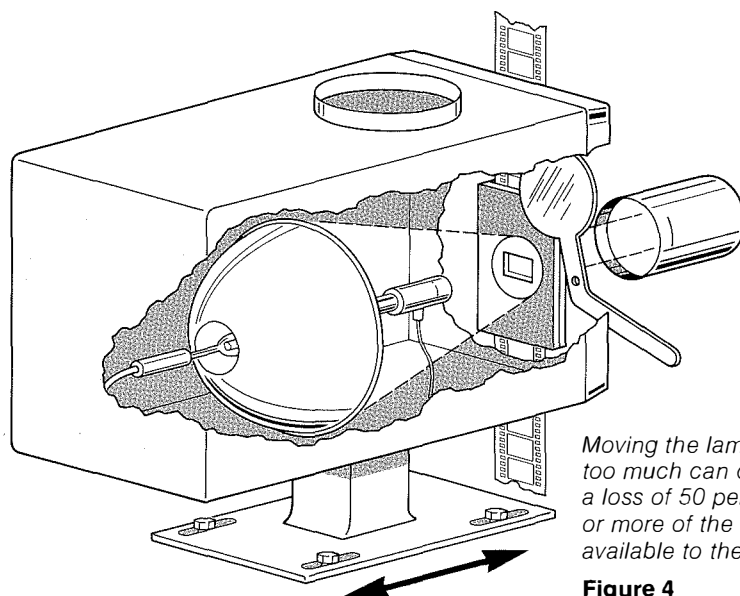
**Figure 4**

*Moving the lamphouse too much can cause a loss of 50 percent or more of the light available to the screen.*

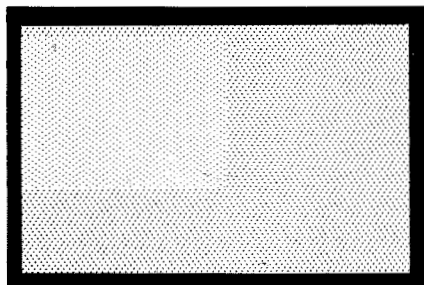
**Figure 5**

If it were possible to compare an original piece of your screen with your present screen, you might be quite surprised at the difference you would see (Figure 5). If you do not have a sample of the original screen material used in your theatre, a fairly good comparison can be made by using a sheet of bond paper, a clean white handkerchief, or a white tissue. The long-term effects of smoking, dust, and air circulation can really darken a screen and change its color. These changes occur very slowly and, of course, would pass unnoticed during casual glances at the screen. The screen shown in Figure 5 did not appear to be dirty and discolored until this direct comparison was made with a section of unused screen material.

*Direct comparisons like this cannot always be made, but a sheet of plain white bond paper is a reasonable substitute. The loss shown here is about 25 percent.*

Actual measurements in the theatre showed a light loss of about 25 percent. A sheet of white bond paper measured within about 5 percent of the new screen sample, so it could be used effectively as a "new screen" substitute to provide a visual means of checking the condition of your screen. If you discover that your screen is dirty and discolored, it can be professionally cleaned. We would not recommend that you attempt to do the job yourself unless you are thoroughly familiar with the technique.\*

Sometimes dust and dirt accumulations can be removed by vacuum cleaning with a very soft cloth or a

screen brush. Be especially careful not to allow the dirt particles to scratch the delicate reflective coating of the screen. Dust collected in the screen perforations can be removed by using a vacuum cleaner and a soft brush on the back side of the screen. Discoloration due to nicotine usually cannot be removed without serious damage to the surface of the screen. Whatever you attempt in the way of cleaning, try it first in a corner. Check the manual for your screen or contact your theatre supply dealer if you have any questions about cleaning your screen.

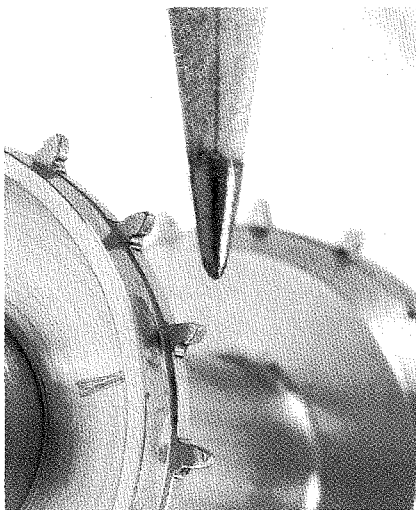
**Figure 6**

*Hook-shaped intermittent-sprocket teeth will almost always cause perforation damage and severe image unsteadiness.*

A worn intermittent sprocket should be changed, but what happens if you do not change it? First, perhaps a discussion of the word "worn" is in order. Is the sprocket diameter worn down? Are the sprocket teeth worn flat? Of course, it is neither of these extremes, but rather a groove worn into the leading edge of the sprocket tooth (see Figure 3) near the base. As more and more film is run through the projector, the groove wears deeper and actually causes the tooth to become hook shaped (Figure 6). At this point, perforation damage is likely to occur along with unacceptable screen image unsteadiness and a noticeable increase in film noise level.

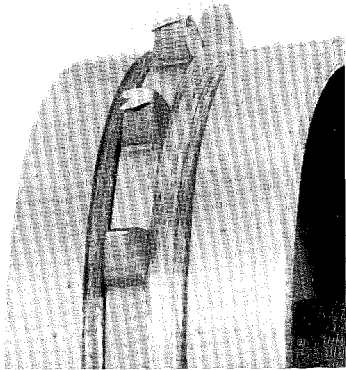
**Figure 7**

A damaged tooth with a burr (Figure 7) can raise havoc with the perforations in a misaligned projector. The sharp edges of a tooth can also score the perforation wall and start long cracks that can ruin an entire reel of film. During projection, it is often difficult to hear the telltale noises that usually

*Any sprocket with a burr on even one tooth should be replaced.*

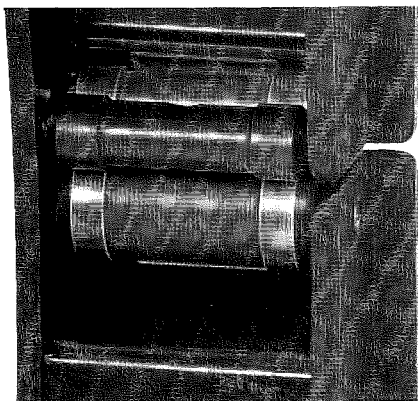
**Figure 8**

longer necessary, much of the unmodified equipment still in the field uses them. Because their function was to close the film opening in case of a film break and potential fire, they were designed to be heavy and provide a very narrow opening to allow the film to pass through. At this point, dirt, oily matter, and film chips can accumulate and prevent free turning of the rollers, or they can become so clogged that one or more of the rollers will not turn at all. If this occurs, the "frozen" roller will develop flat spots on the shoulders and cause the center of that roller to come into direct contact with image area of the film. Under these conditions, the relatively soft emulsion of a new print can be badly abraded. Because the rollers are partly obscured in their mounting assembly, they should be checked frequently to see that they are clean and rotating freely. Newer equipment does not contain these roller clusters, but guide rollers are also designed with the same sort of shallow undercut areas and can wear flat if they "freeze."

*A lot of abrasion can be avoided if the fire rollers are checked frequently to make sure that they have not become stuck.*

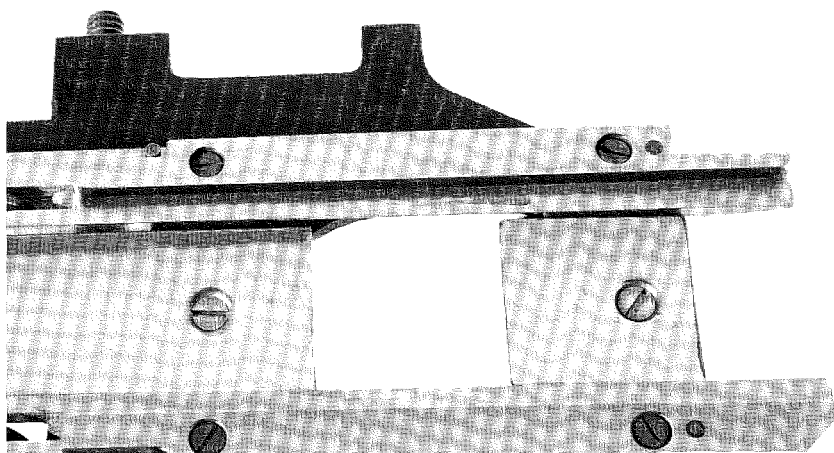
**Figure 9**

The projector gate can be another source of film damage. As mentioned earlier in the section dealing with screen image unsteadiness, hard deposits on the trap rails (Figure 9) can cause excessive tension and perforation damage. Remember, too, that this type of tension causes unnecessary wear of gate components and puts a greater strain on film perforations and the intermittent movement.

*Be sure to keep the gate area free of any deposits that might cause film to stick.*

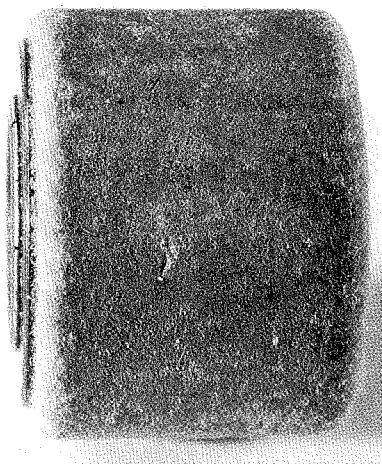
**Figure 10**

*The tiny bits of debris that are embedded in this roller caused significant abrasion in the image area.*

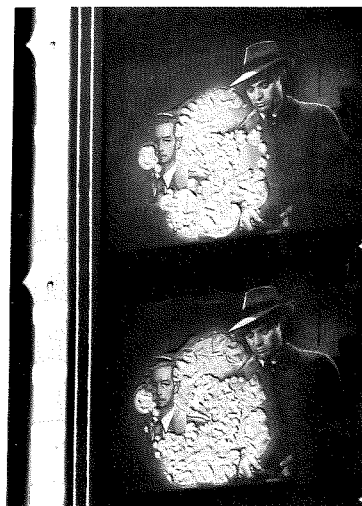
**Figure 11**

The potential contribution of the lamphouse to film damage should not be overlooked. The occurrence of such damage appears to have decreased in proportion to the reduced use of black-and-white film, but the possibility is still there. Particularly in the drive-ins, where there is a strain to get the last "ounce" of light on the screen, a black-and-white feature can become easily embossed

*Blistered films such as this must be thrown out, but blistering can be prevented easily by proper adjustment of the lamphouse.*

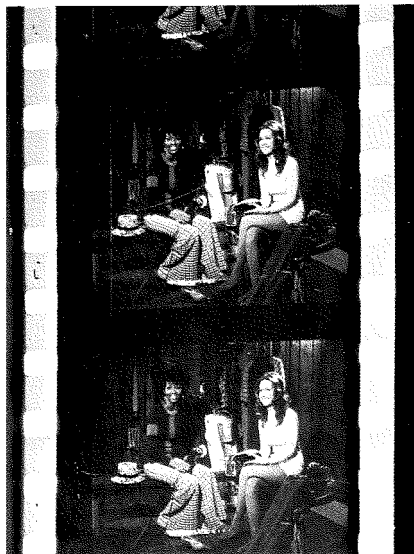
**Figure 12**

in the direction towards the film. You might not notice this type of blistering during normal projection because it usually occurs only on the top or bottom edge of the projected frame and thus ends up on the black screen masking area. A change in framing, however, will quickly show a small horizontal line of blisters near the top or bottom of the screen image. And if the picture is cropped smaller than normal for the particular format, the next projectionist will not be able to frame the blisters out if the correct, but larger, aperture plate is used.

*Frame-line blistering occurs whenever projected film touches the edge of the aperture plate. (See bottom of picture.)*

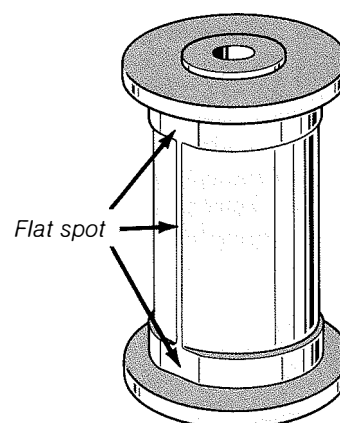
**Figure 13**

rollers to see that they rotate freely. We have observed instances where the rollers had become stuck and the constant friction caused by film passing over them at high speeds had worn the rollers flat all the way across (Figure 13). The abrasion caused by film passing over a flat roller can be extensive . . . especially on a new print with a softer emulsion. Because the roller cover assembly and the film itself obscure the roller, its rotation is not easily observed. Check these rollers frequently and be sure they turn freely and are properly lubricated. If a roller has developed any flat spots, replace it, even if it does seem to turn freely. No matter what type of rewinding equipment you use, be sure that continuous tension is maintained on the supply reel. Loose laps of film can easily cause damage from cinch marks during an abrupt start or stop. If the film is oily, it can also cause kink damage (Figure 14) as well as the cinch marks.

*Flat spots can develop if rollers are not checked frequently to make sure they are turning freely and are properly lubricated.*

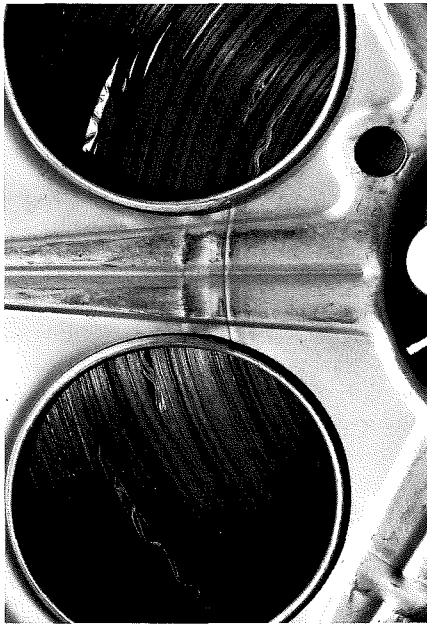
**Figure 14**

Watch out for oil on your film; it can cause kinking as well as abrasion.

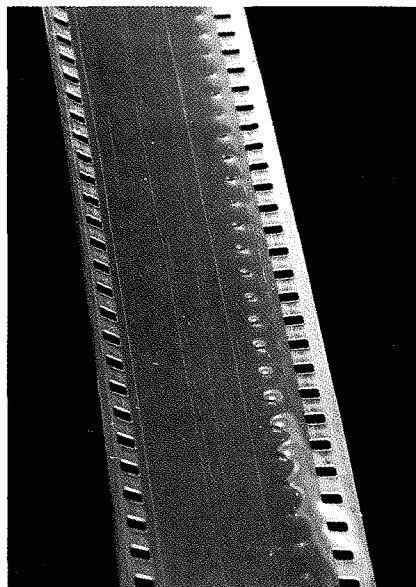
**Figure 15**

Whether splicing by tape or cement, check film alignment in the splicer. Protruding corners usually cause trouble in a projector. Some exchange personnel trim the corners of an out-of-line splice, but too much of a shift in position, as the film goes through the projector gate or over the sprockets, can cause "roping" (Figure 15) when the film comes off the sprocket.

*Roping; this unwelcome catastrophe is easy to avoid—make sure your splices are aligned accurately.*

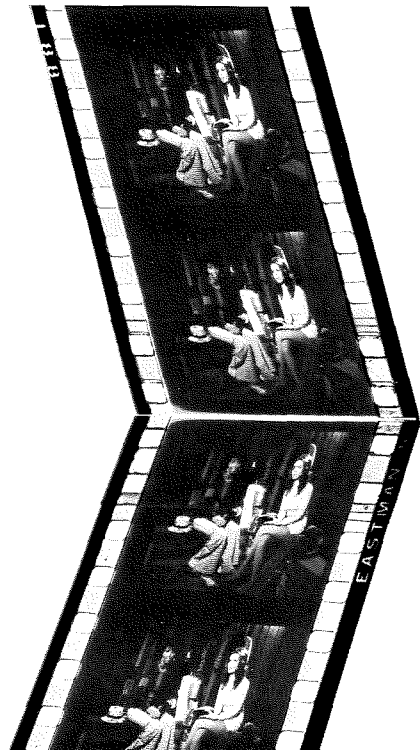
**Figure 16**

Butt-type tape splices demand a precise cut on both film ends to butt intimately. Otherwise the splice tends to collapse or hinge (Figure 16). Trade reports from theatres indicate that butt tape splices do, in time, hinge or collapse, no matter how precisely they are made. Apparently, a slight separation occurs between the two film ends due to the heat and tension experienced during repeated showings. The gap allows the extremely thin splicing tape to fold from lack of support by the film. To avoid the possible film damage and audience annoyance that could occur because of hinged splices, remake any butt tape splices that show a noticeable gap between the film ends.

*To avoid splice collapse or hinging, remake butt splices that show a gap.*
